AFRL-ML-TY-TP-2004-4516

POST-FIRE DAMAGE ASSESSMENT OF A COMPOSITE WINGBOX

May 2004

THIS TECHNICAL PAPER HAS BEEN REVIEWED AND IS APPROVED FOR PUBLICATION. IT WAS PRESENTED AT THE 2004 SAMPE CONFERENCE, LONG BEACH, CALIFORNIA; 16-20 MAY 2004.

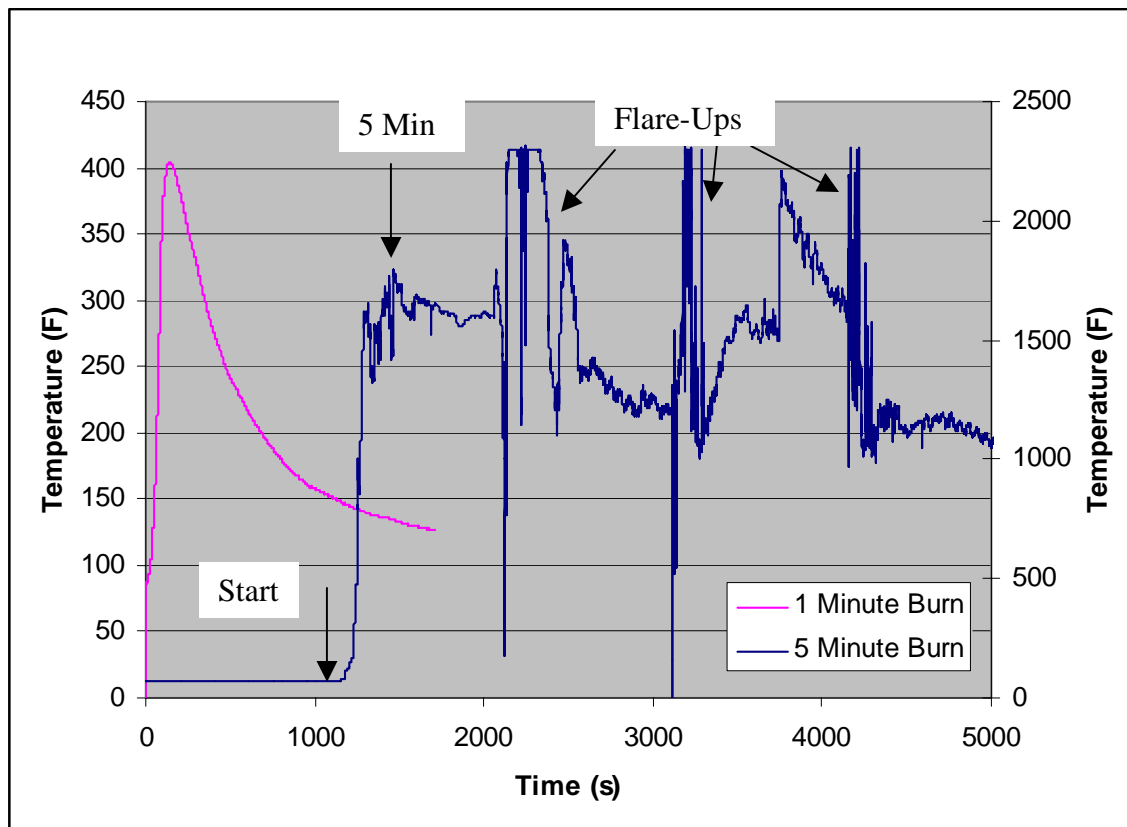
Typical thermal profiles are shown in Figure 5 for both burn tests, as measured on the exposed side (bottom) of the wing boxes. As expected, the 5 minute burn results in composite ignition and continued heat release and burn despite extinguishing the flame, indicating deep-seated fires within the structure. Optical micrograph and SEM analyses are ongoing.

Figure 5 Typical Thermal History of Samples from both Wing Boxes

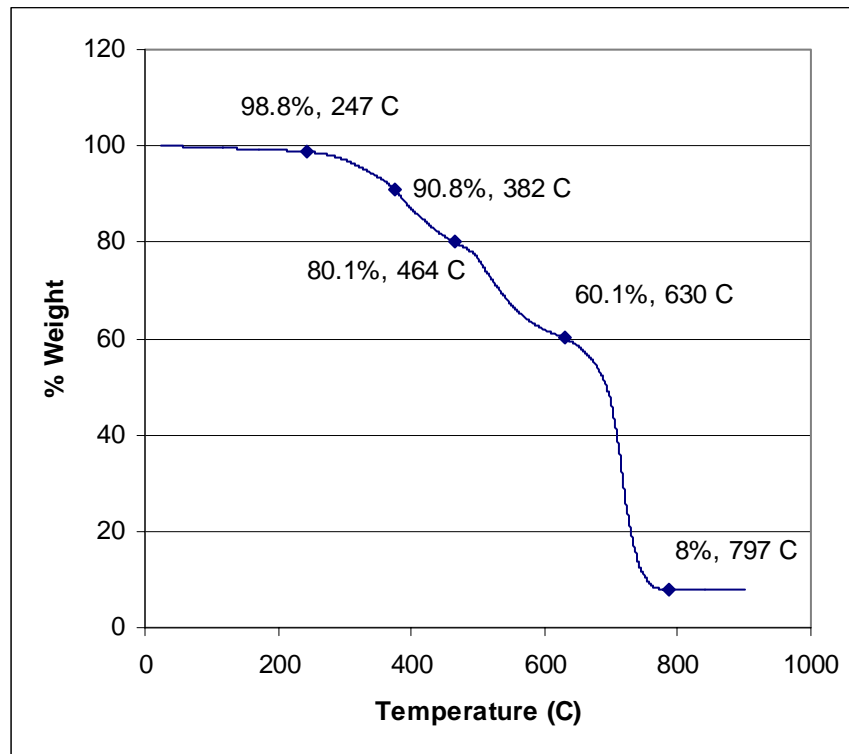
Thermogravimetric analysis of wing box samples was done using a TA Instruments Q500 TGA. Air was used as the purge gas with a flow rate of 5C/min. Figure 6 shows the averaged weight loss of the sample as a function of temperature. Initially 0.5% weight loss up to 140C was observed, indicating the moisture lost which agrees well with our drying experiment measurement (~0.4%). The next significant step occurred at 1.2% up to 248C, which maybe due to decomposition of the surface coating (paint etc) of the wing box. However, this needs to be verified with additional experiments. The third weight loss (10%) step occurs up to 382C followed by 40% weight loss up to 630C, which correlates well with the expected resin content (~ 40%). The final weight loss of approximately 92% is due to carbon fiber decomposition. However, depending on the heat flux (much higher in a fire compared to the TGA) and thermal properties of the fiber and resin decomposition may have occurred at lower temperatures in the wing box samples. The TGA results indicate an “idealized” decomposition pattern of the composite material used in the wing box. Further investigation is ongoing.

Figure 6 Degradation Behavior of AS4/3501-6. Sample from 1 minute Wing Box (1W-T-4)

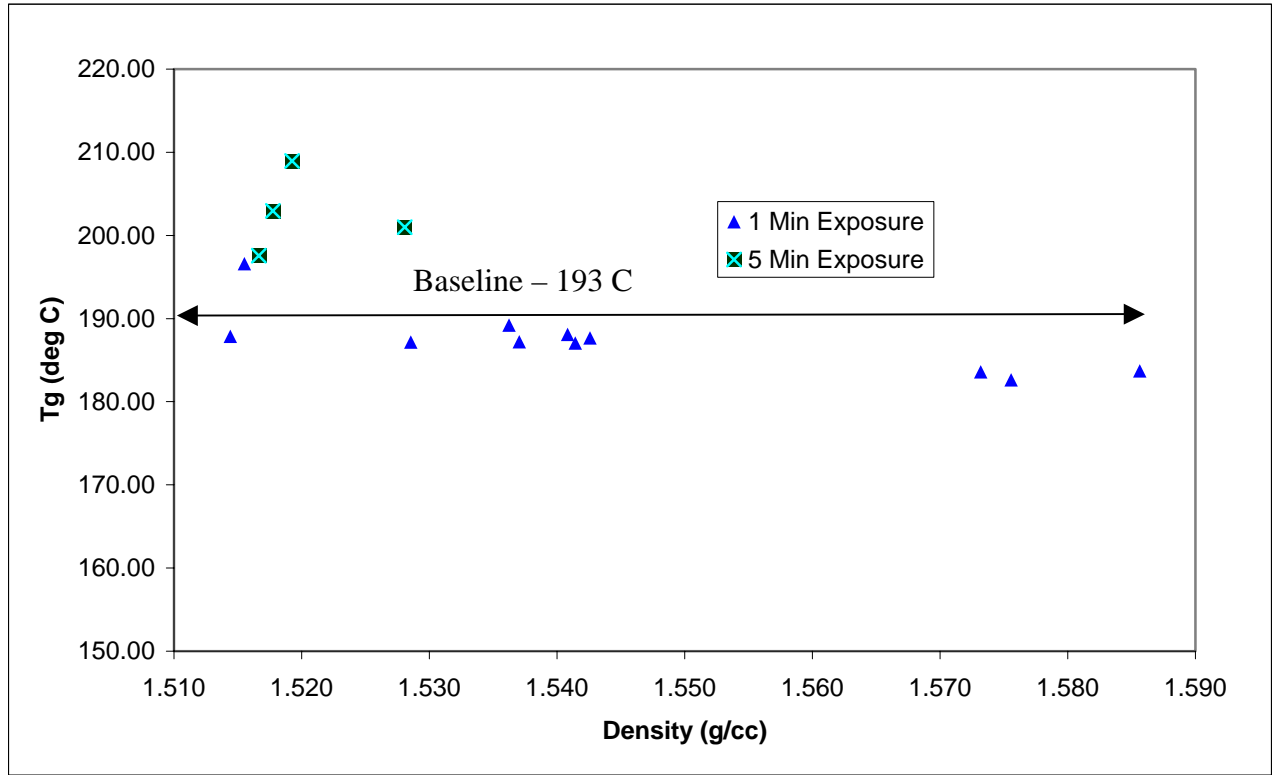
A comparison of Tg vs measured density is shown in Figure 7 for the 1 minute and 5 minute samples. The higher exposure samples (that were measurable) show a consistently high Tg compared to the lower exposure samples. While Tg values are reasonably consistent for the 1W samples, the wide variations in density may be due to the following reasons: coating loss on samples showing some surface damage will reduce density (reductions average ~4%), while samples that show scorching and pitting may have localized resin loss, thus artificially increasing

density. All the 2W samples will show lower density due to fiber oxidation and resin decomposition. This hypothesis is being further investigated and validated.

Figure 7 Density and Tg variations in the Wing Box Samples

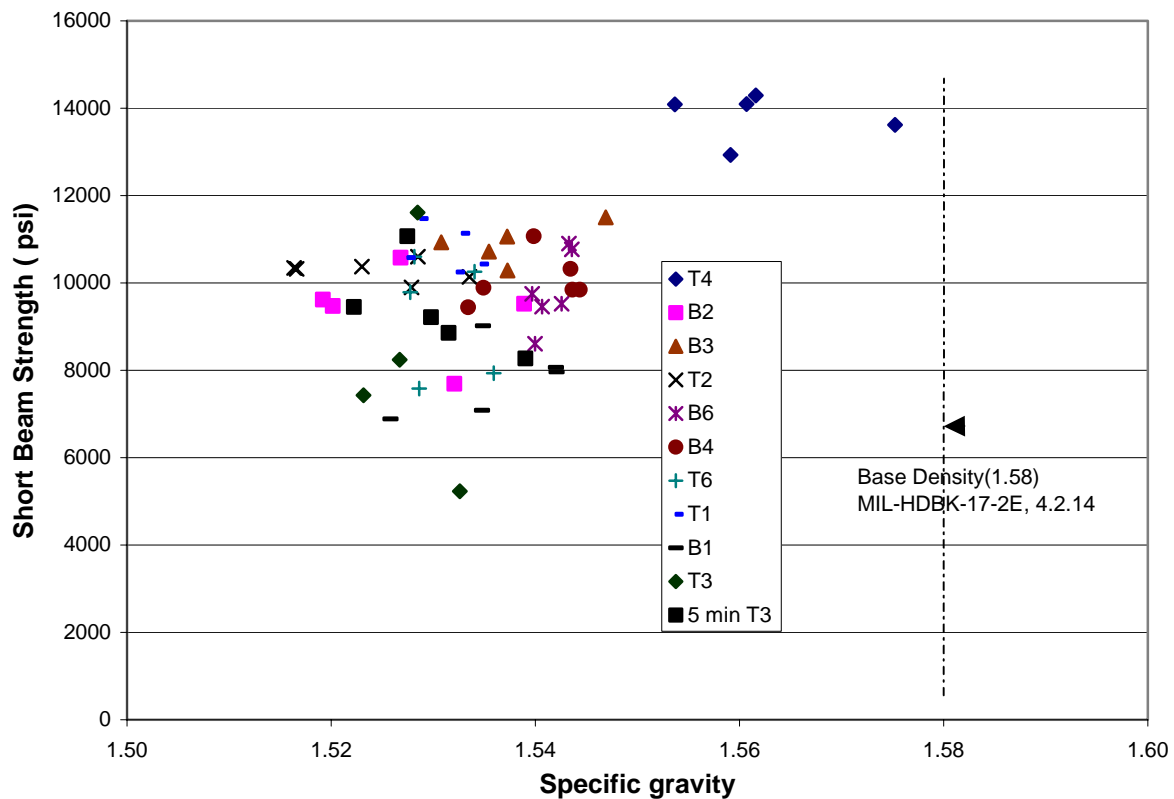
Short beam shear strengths were measured for specimens from both wing box samples. Average values are listed in Table 3, with the actual values plotted as a function of density in Figure 8. The trend of decreasing shear strength with decreasing density is clear and an examination of the failure modes shows a mix interlaminar shear and tension/compression failure. This is expected due to the surface damage on the 1W samples and ongoing flexure tests are expected to better quantify the effect surface damage.

Figure 8 Short Beam Shear Strengths as a function of Wing Box Sample Density
